# Hobby-Eberly Telescope Site Status Report \*

## McDonald Observatory, University of Texas at Austin

2018-07-05 12:00:06 to 2018-07-06 23:59:59 UTC

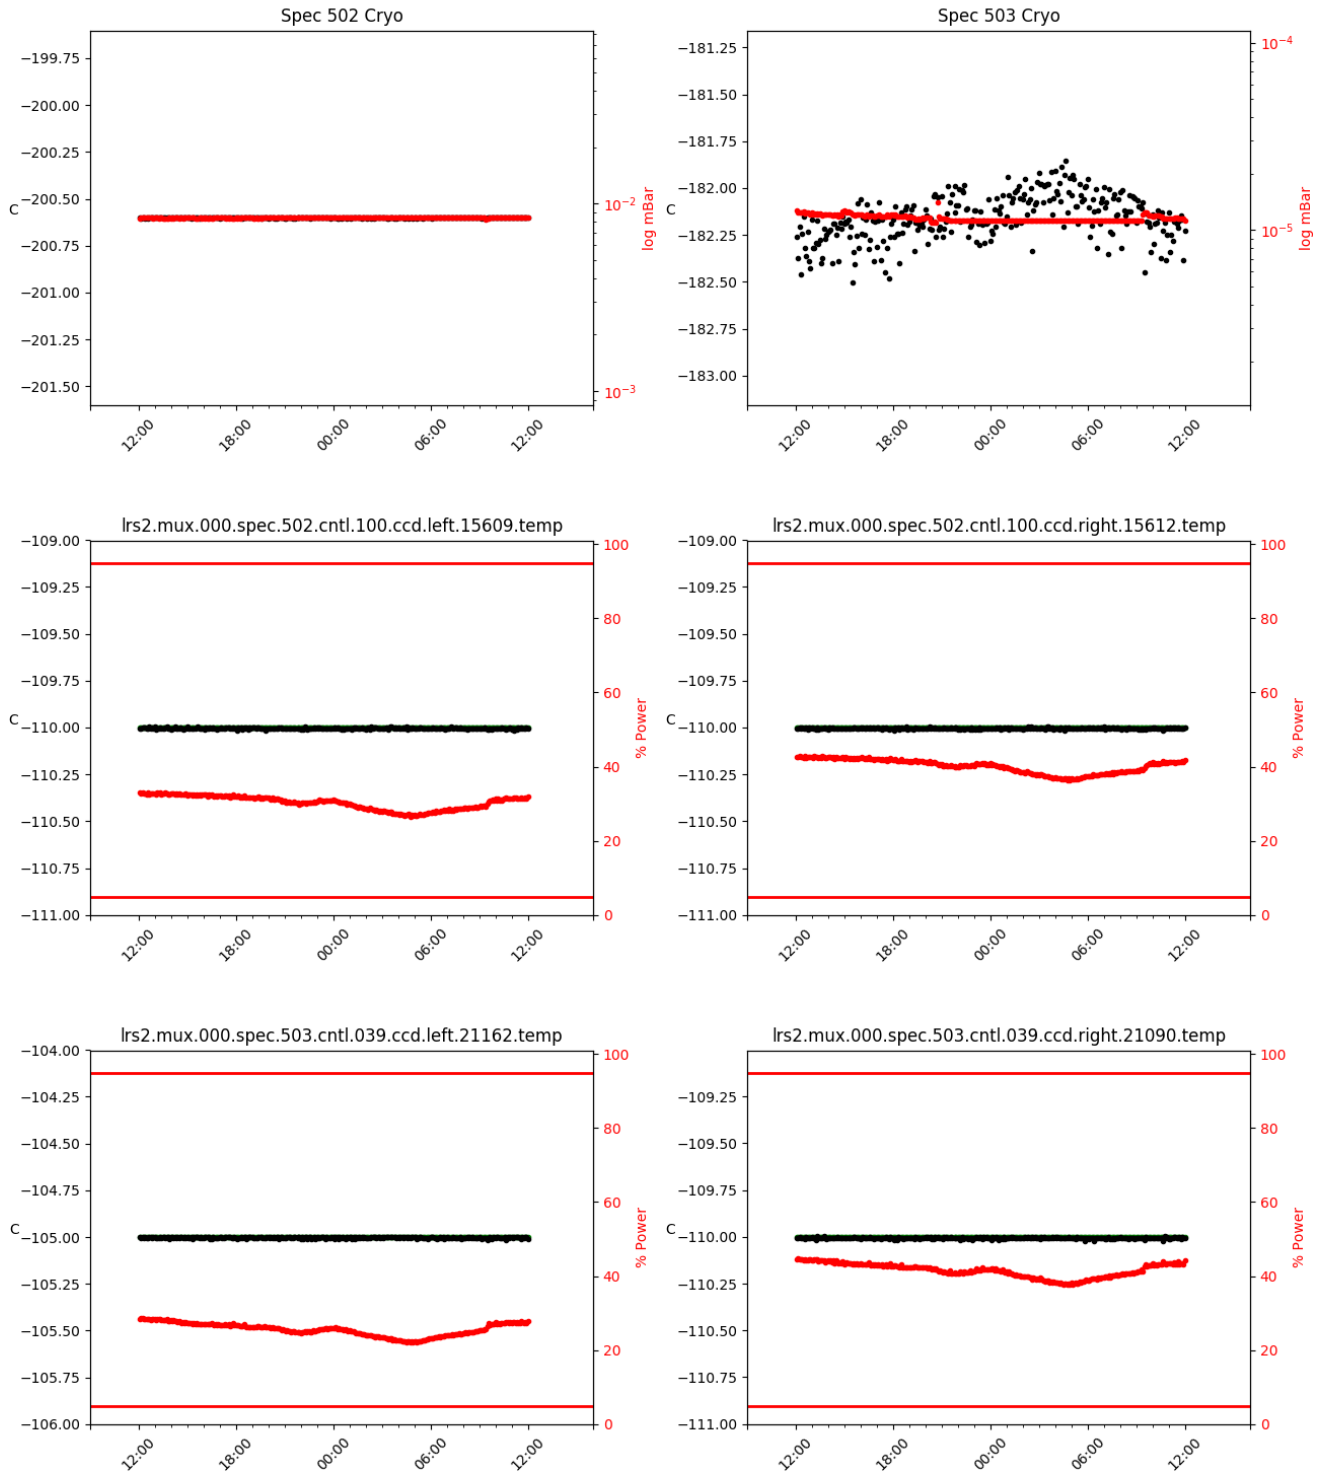
### 2.2 lrs2

For the Spectrograph Cryo plots the Black point are the cryo temperature reading and the Red points are the cryo pressure in Torr on a log scale with the scale on the right hand vertical axis.

For all Spectrograph Temperature plots, the Black points are the ccd temperature reading, the Green points are the ccd set point, and the Red points are the percentage heater power with the scale on the right hand vertical axis. The two straight Red lines are the 5% and 95% power levels for the heater.

Uptime: 52:53:36 hh:mm:ss.

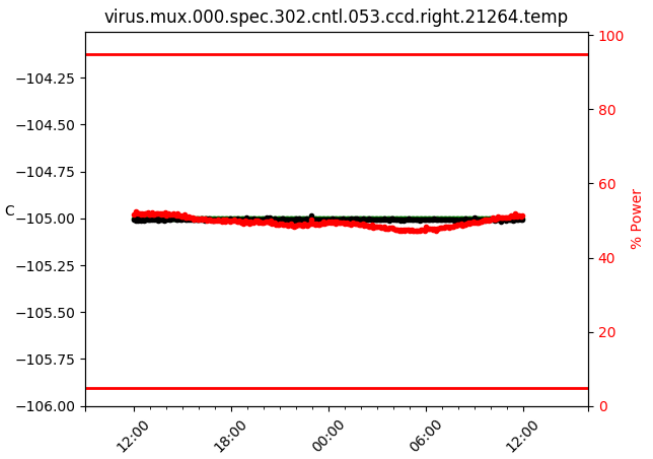
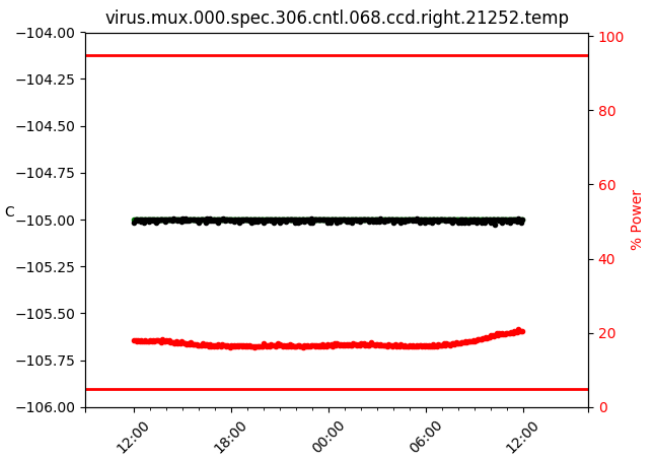
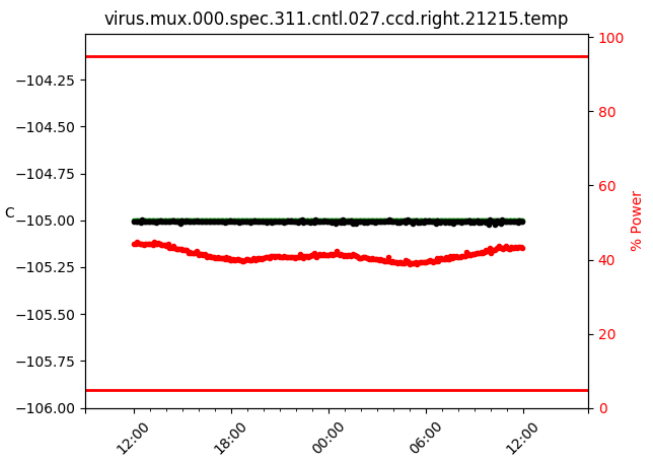
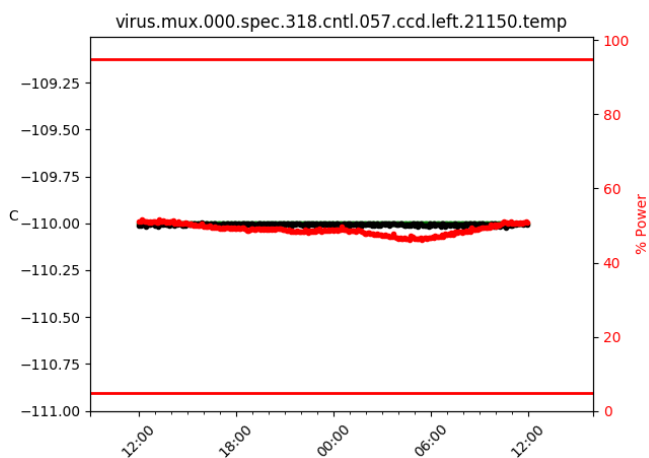
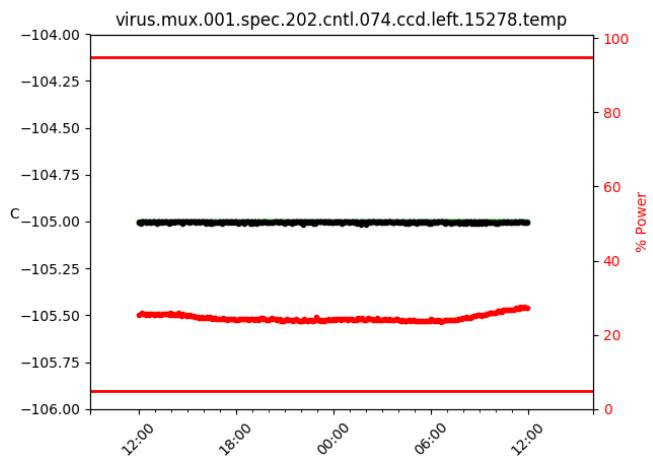
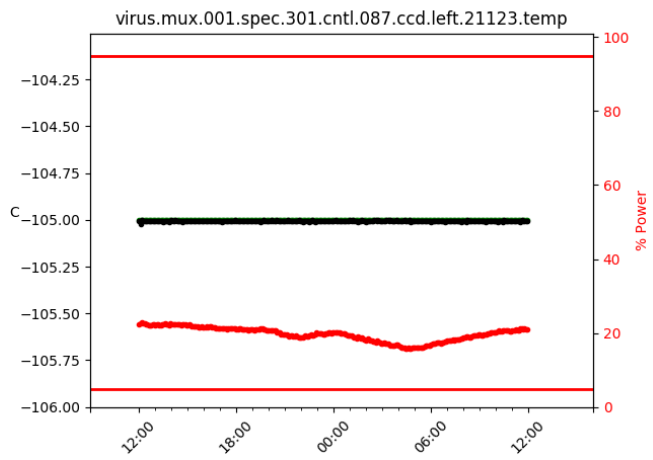
## 2.3 virus

Uptime: 30:29:52 hh:mm:ss.
